## BISBEE-DOUGLAS INTERNATIONAL AIRPORT Douglas / Cochise County, Arizona

### AIRPORT MASTER PLAN - 1997

## SECTION 2: INVENTORY OF EXISTING CONDITIONS

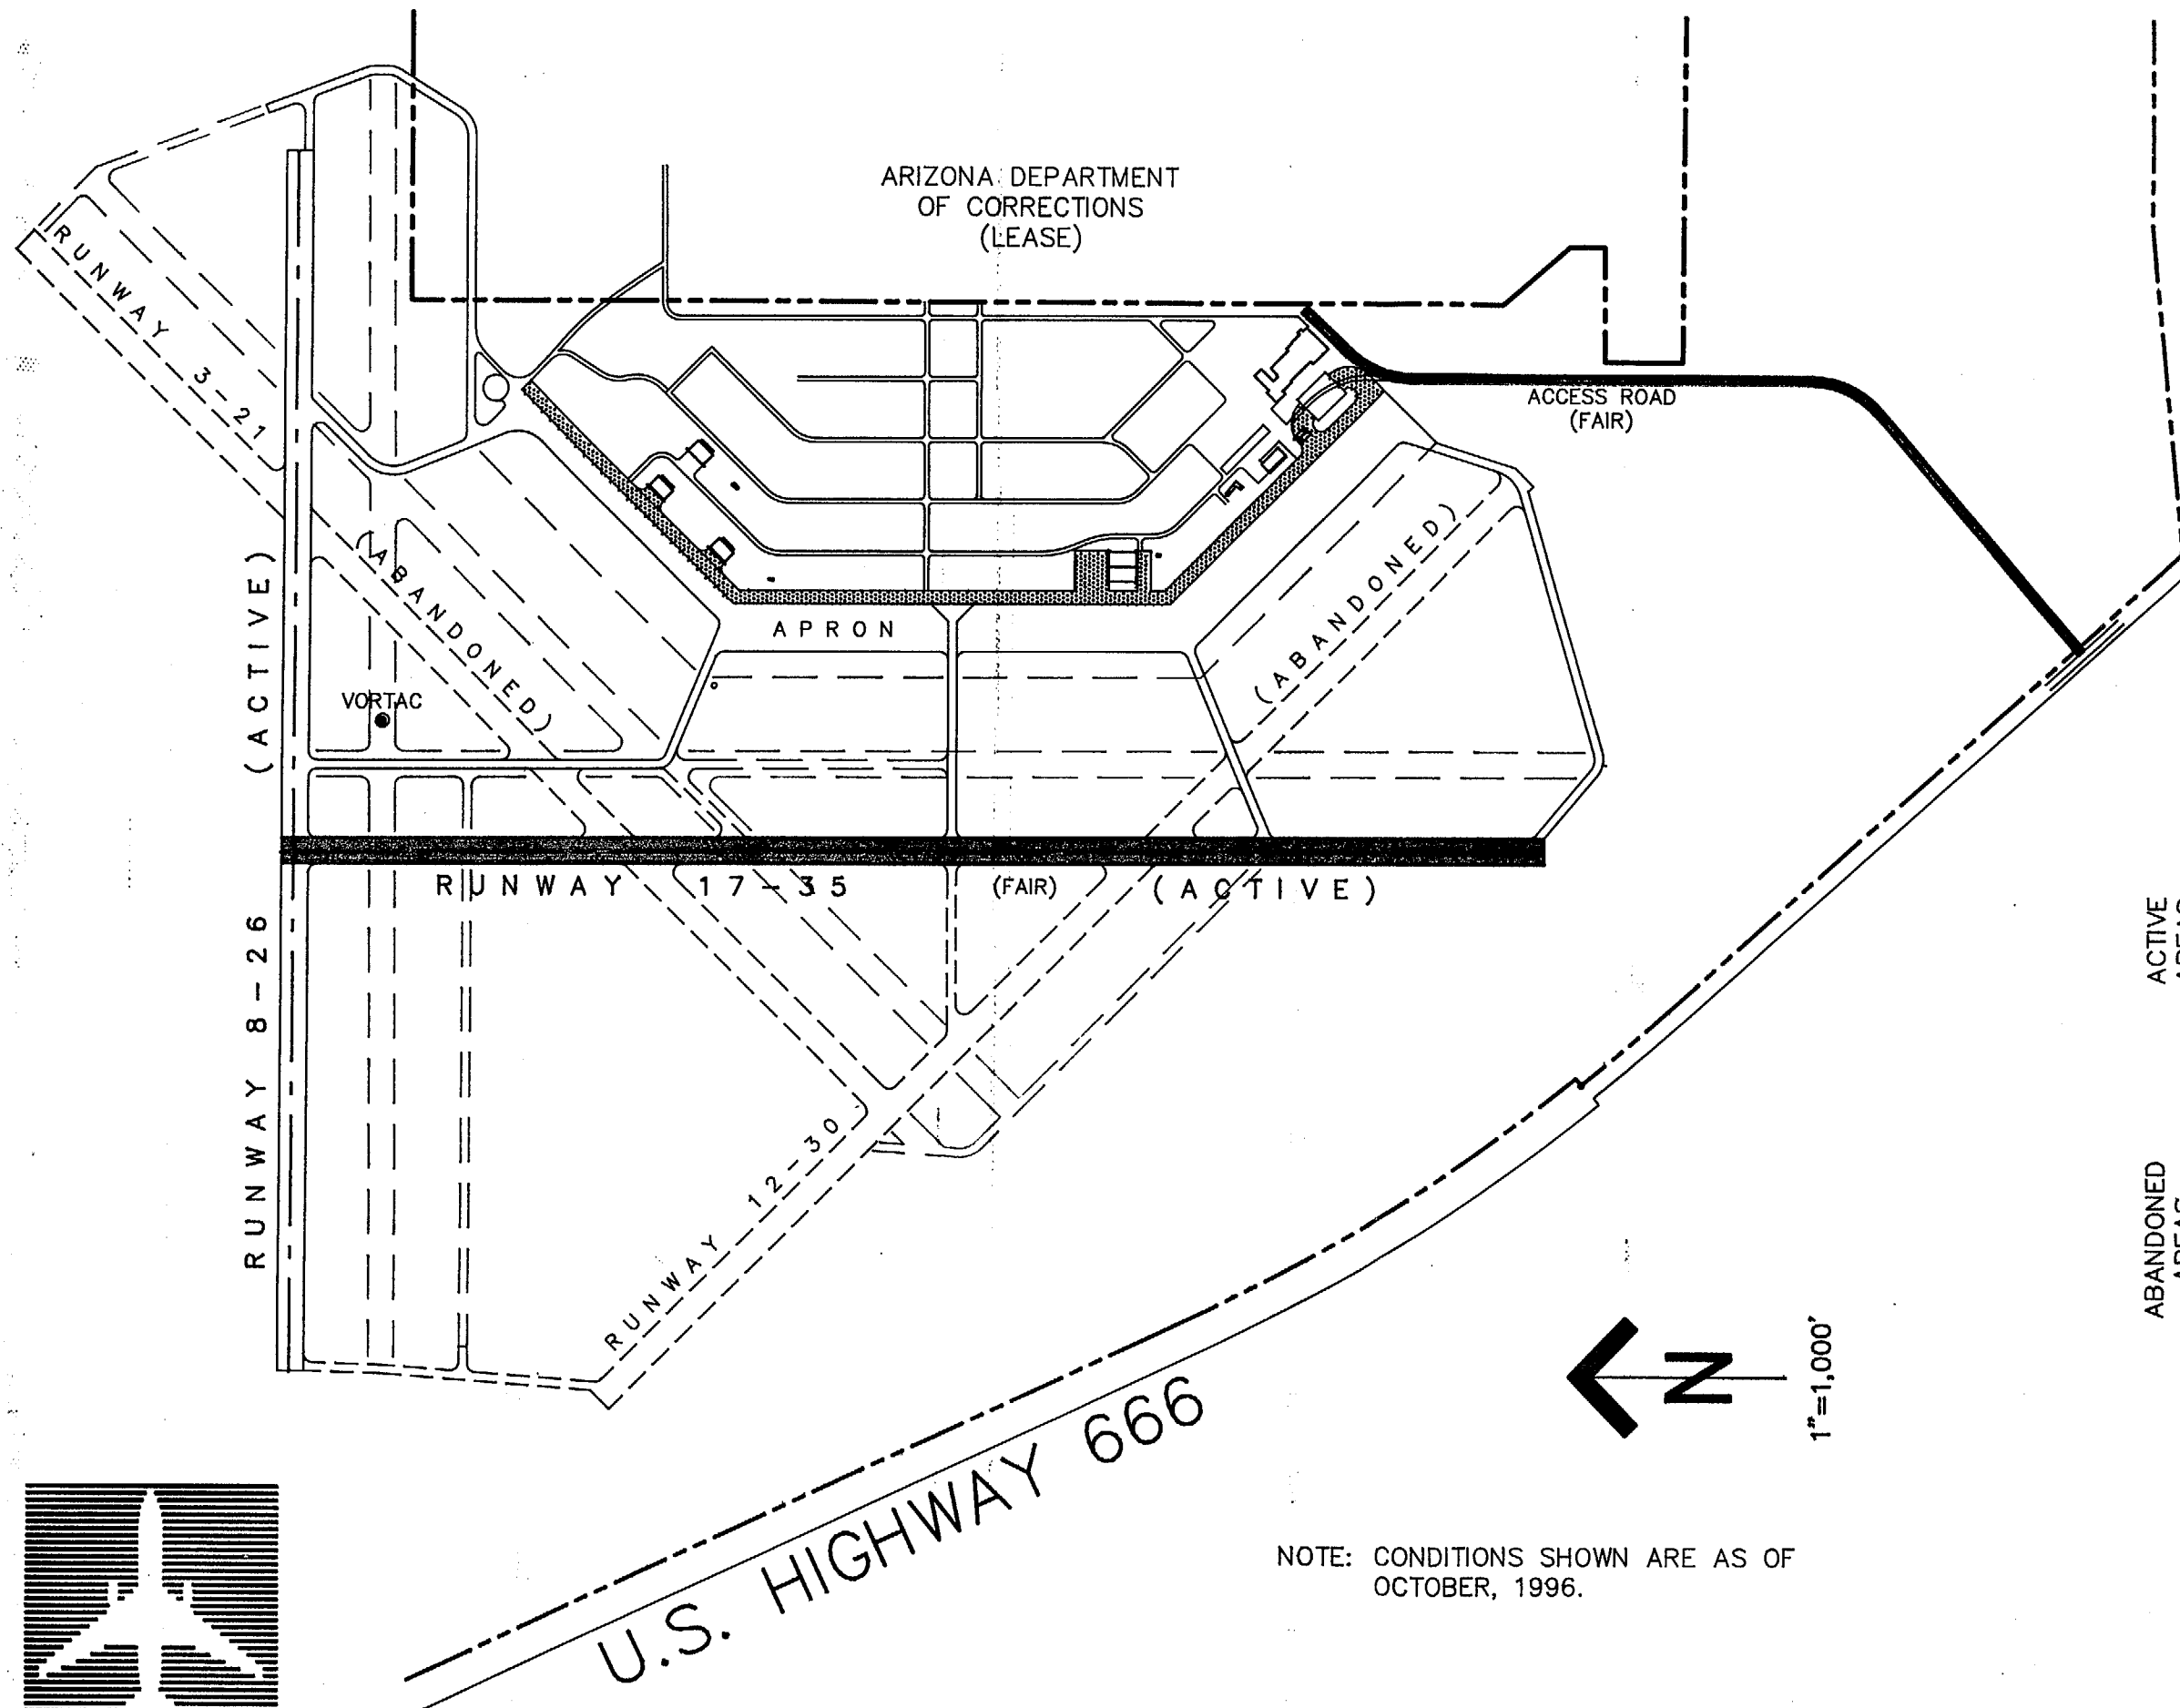
## Pavement Condition Index Map

As observed in October of 1996, Runway 17-35 is in Fair to Poor condition. In 1992, a preservative seal coat was applied to the center 60' of this runway. The aggregate used in the seal coat is 0.5" nominal size. Local pilots have commented that the resulting surface friction characteristics of this aggregate causes extreme tire wear. Weeds and desert vegetation are thick in places along the runway shoulders, sometimes screening the runway lights.

Runway 8-26 was observed to be in Poor condition. The pavement is well beyond its useful life. Weeds and desert vegetation are encroaching upon the paved surface, sometimes extending across the entire pavement width.

All of the existing bituminous taxiways and apron areas are in Poor condition, exhibiting deformation, large cracks and potholes.

The 75' wide concrete apron is in Fair condition. Some panels will require replacement and all joints should be resealed, but most of the apron is usable at the present time.

All landside pavements, except the airport and prison access road, are in Poor condition. The access road is in Fair condition.

A visual engineering investigation of the airport's existing pavements was conducted by ATL, Inc. as a part of the scope of this study. Their recommendation is that all airside pavements be reconstructed, except for a portion of Runway 17-35.

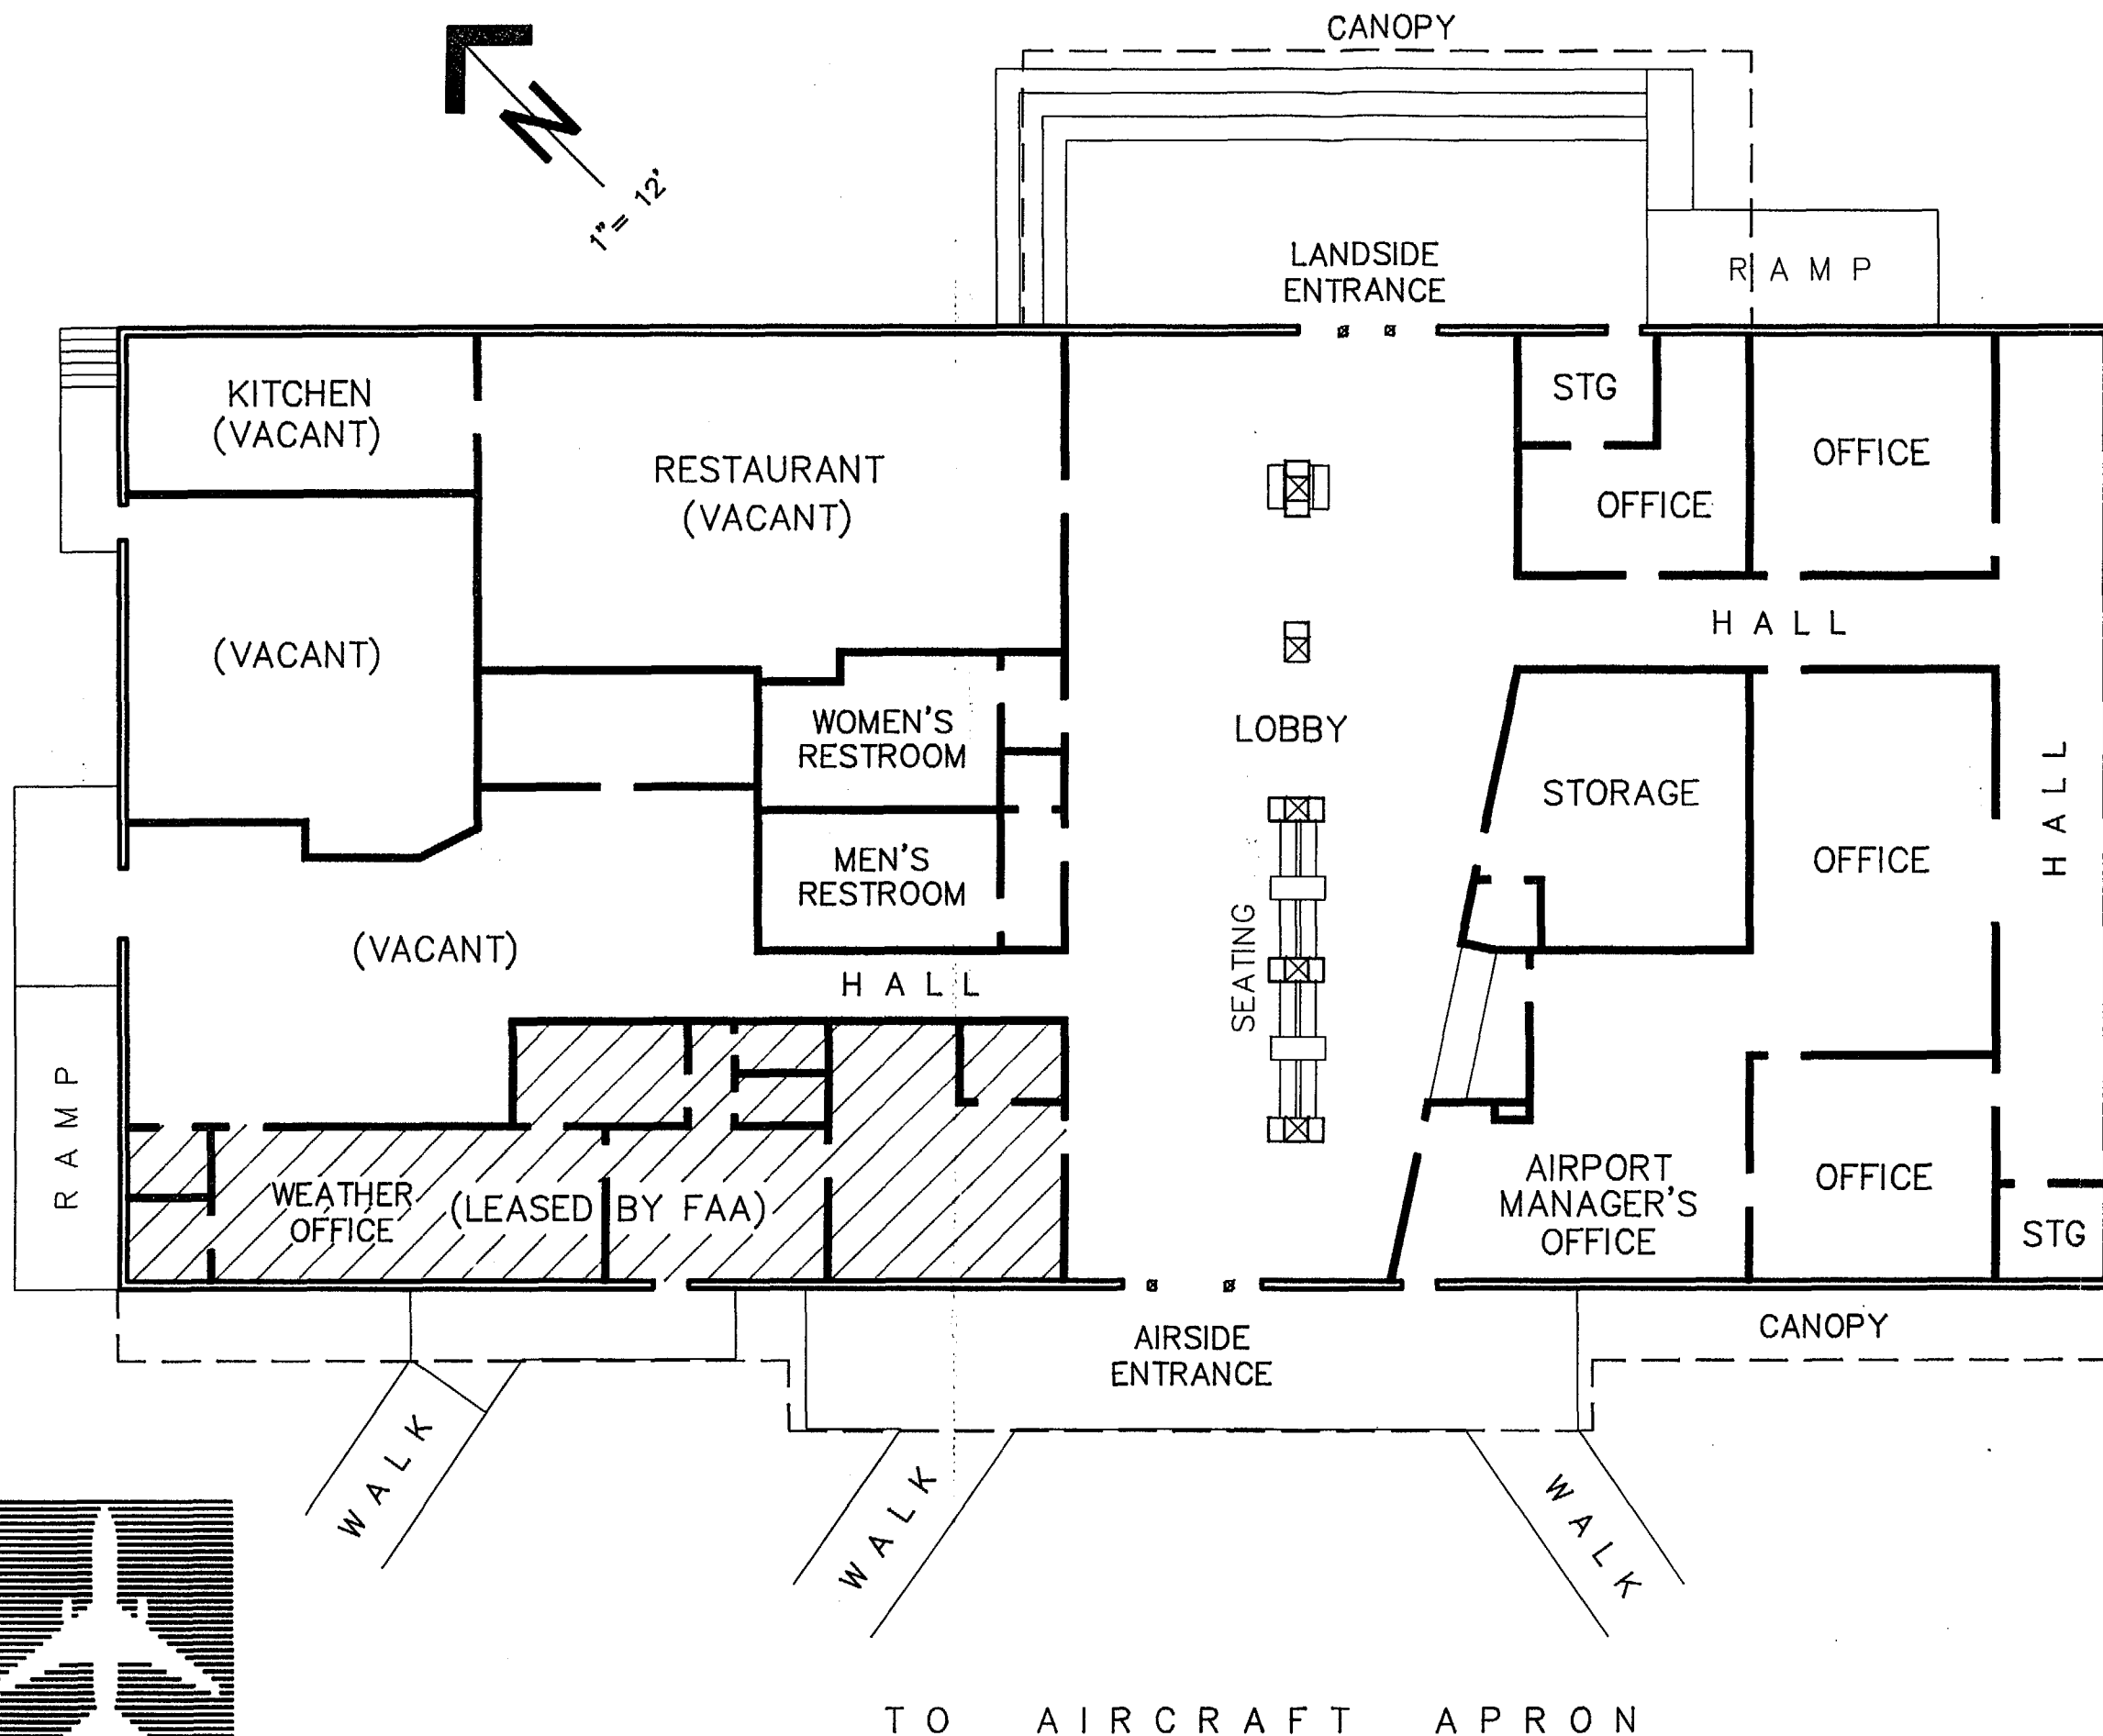
Figure 2-3

In general, the Terminal Building was found to be in Fair condition. The vacant coffee shop is in Poor condition. The lobby and airport manager's office are in Good condition. The balance of the building's interior space is in Fair condition. The major detriment is the existence of asbestos in both exterior siding and interior ceilings.

Thorough investigation and testing of the various structural, electrical, plumbing, mechanical and HVAC systems as well as a hazardous materials investigation is recommended prior to any remodeling or renovations to this building.

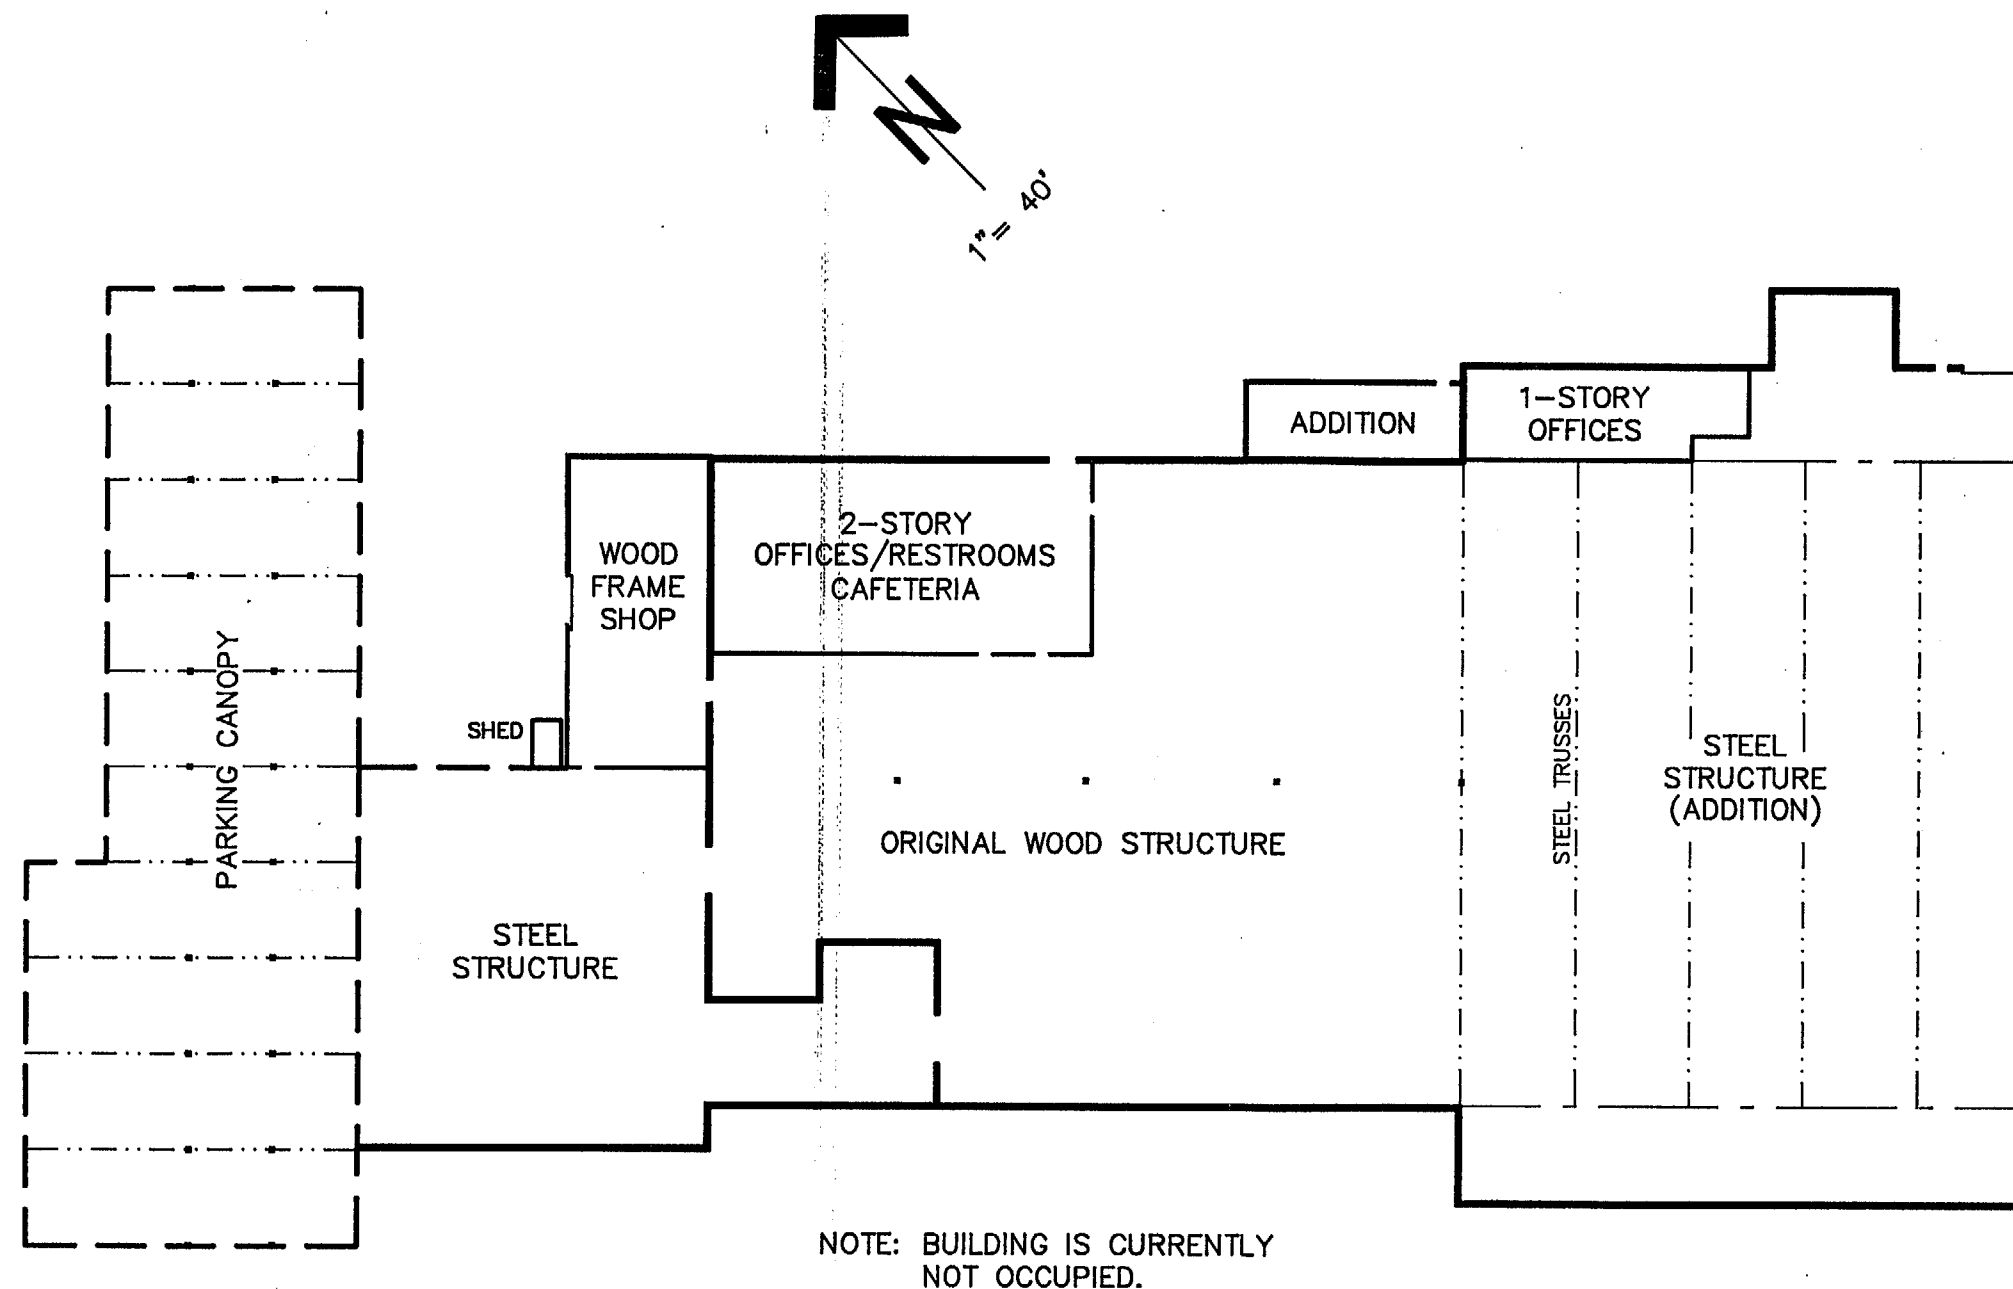
**Figure 2-4**

Water damage was observed at the structural roof members on the original wood frame structure, with resultant deflection. A structural investigation, including deflection testing of the wood trusses, to determine the integrity of the members is recommended. The airport manager indicated that a new roof was installed two and one half years ago (1993). County staff has indicated that this consisted of the application of a 3" layer of foam. No repairs were made to the roof structure.

Building #2 was found to be in generally Poor condition, with the probability of prohibitively expensive structural repairs and remodeling, and replacement of electrical systems being the major detriments to use at this time. The building is presently occupied by owls, and infested with bats and mice.

The structure as it exists does not meet modern building codes with respect to its size and related assemblies. The costs of updating the current assemblies to comply with modern building codes, with the implementation of area separation walls, fire protection systems, and the corrections resulting from structural investigations should be

considered pending a thorough structural, electrical, mechanical, and plumbing investigation.

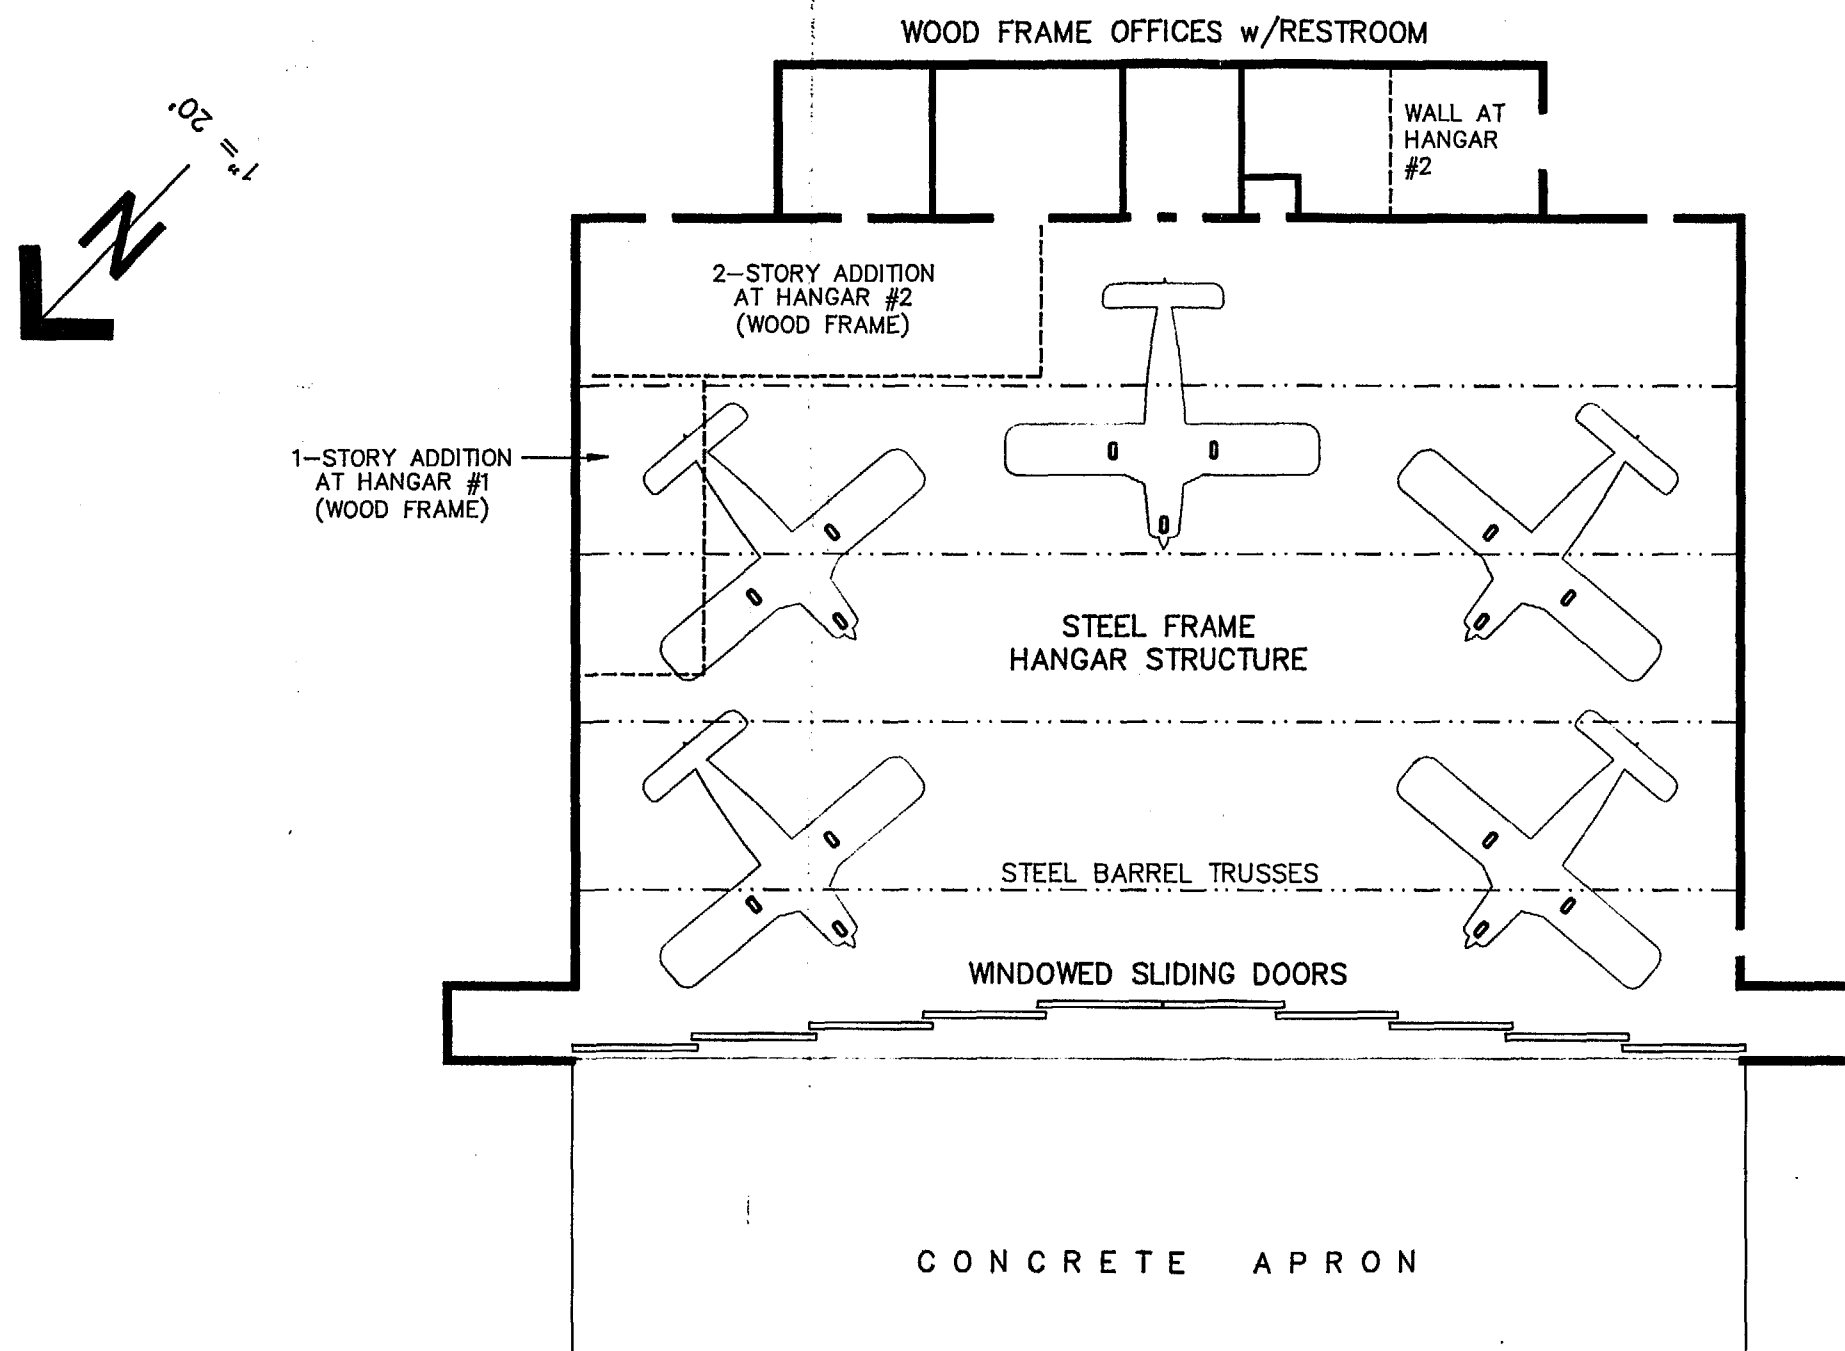
Figure 2-5

Hangars #1, #2 and #3 consist of three nearly identical structures constructed from plans dated 1939, as prepared by the U.S. Engineers Office. The approximate size of each hangar is 12,000 square feet. The hangars were identically constructed with exception of various modifications which were made over time. Construction consists of a combination of wood framing and steel framing members with corrugated metal exterior siding. The roof structure consists of steel barrel trusses with wood sheathing. All three buildings show signs of roofing moisture damage.

Hangar #2 has a two story office addition, and is not currently occupied. The roof of this hangar leaks badly, and the floor drain is clogged causing the hangar to flood during heavy rains.

Hangar #3 is presently not occupied, and has very few improvements. The roof of Hangar #3 is in the most disrepair with fiber board falling from the ceiling. However, this roof does not currently leak as badly as Hangar #2.

The three steel hangars are generally in Fair condition. Major detriments affecting current use are birds and rodents living in the structures, as well as poorly operating hangar doors, leaking roofs, and missing and broken window panes.

A thorough investigation with specific testing of the structural, electrical, and plumbing systems, is recommended for these three structures prior to any remodeling or renovation.

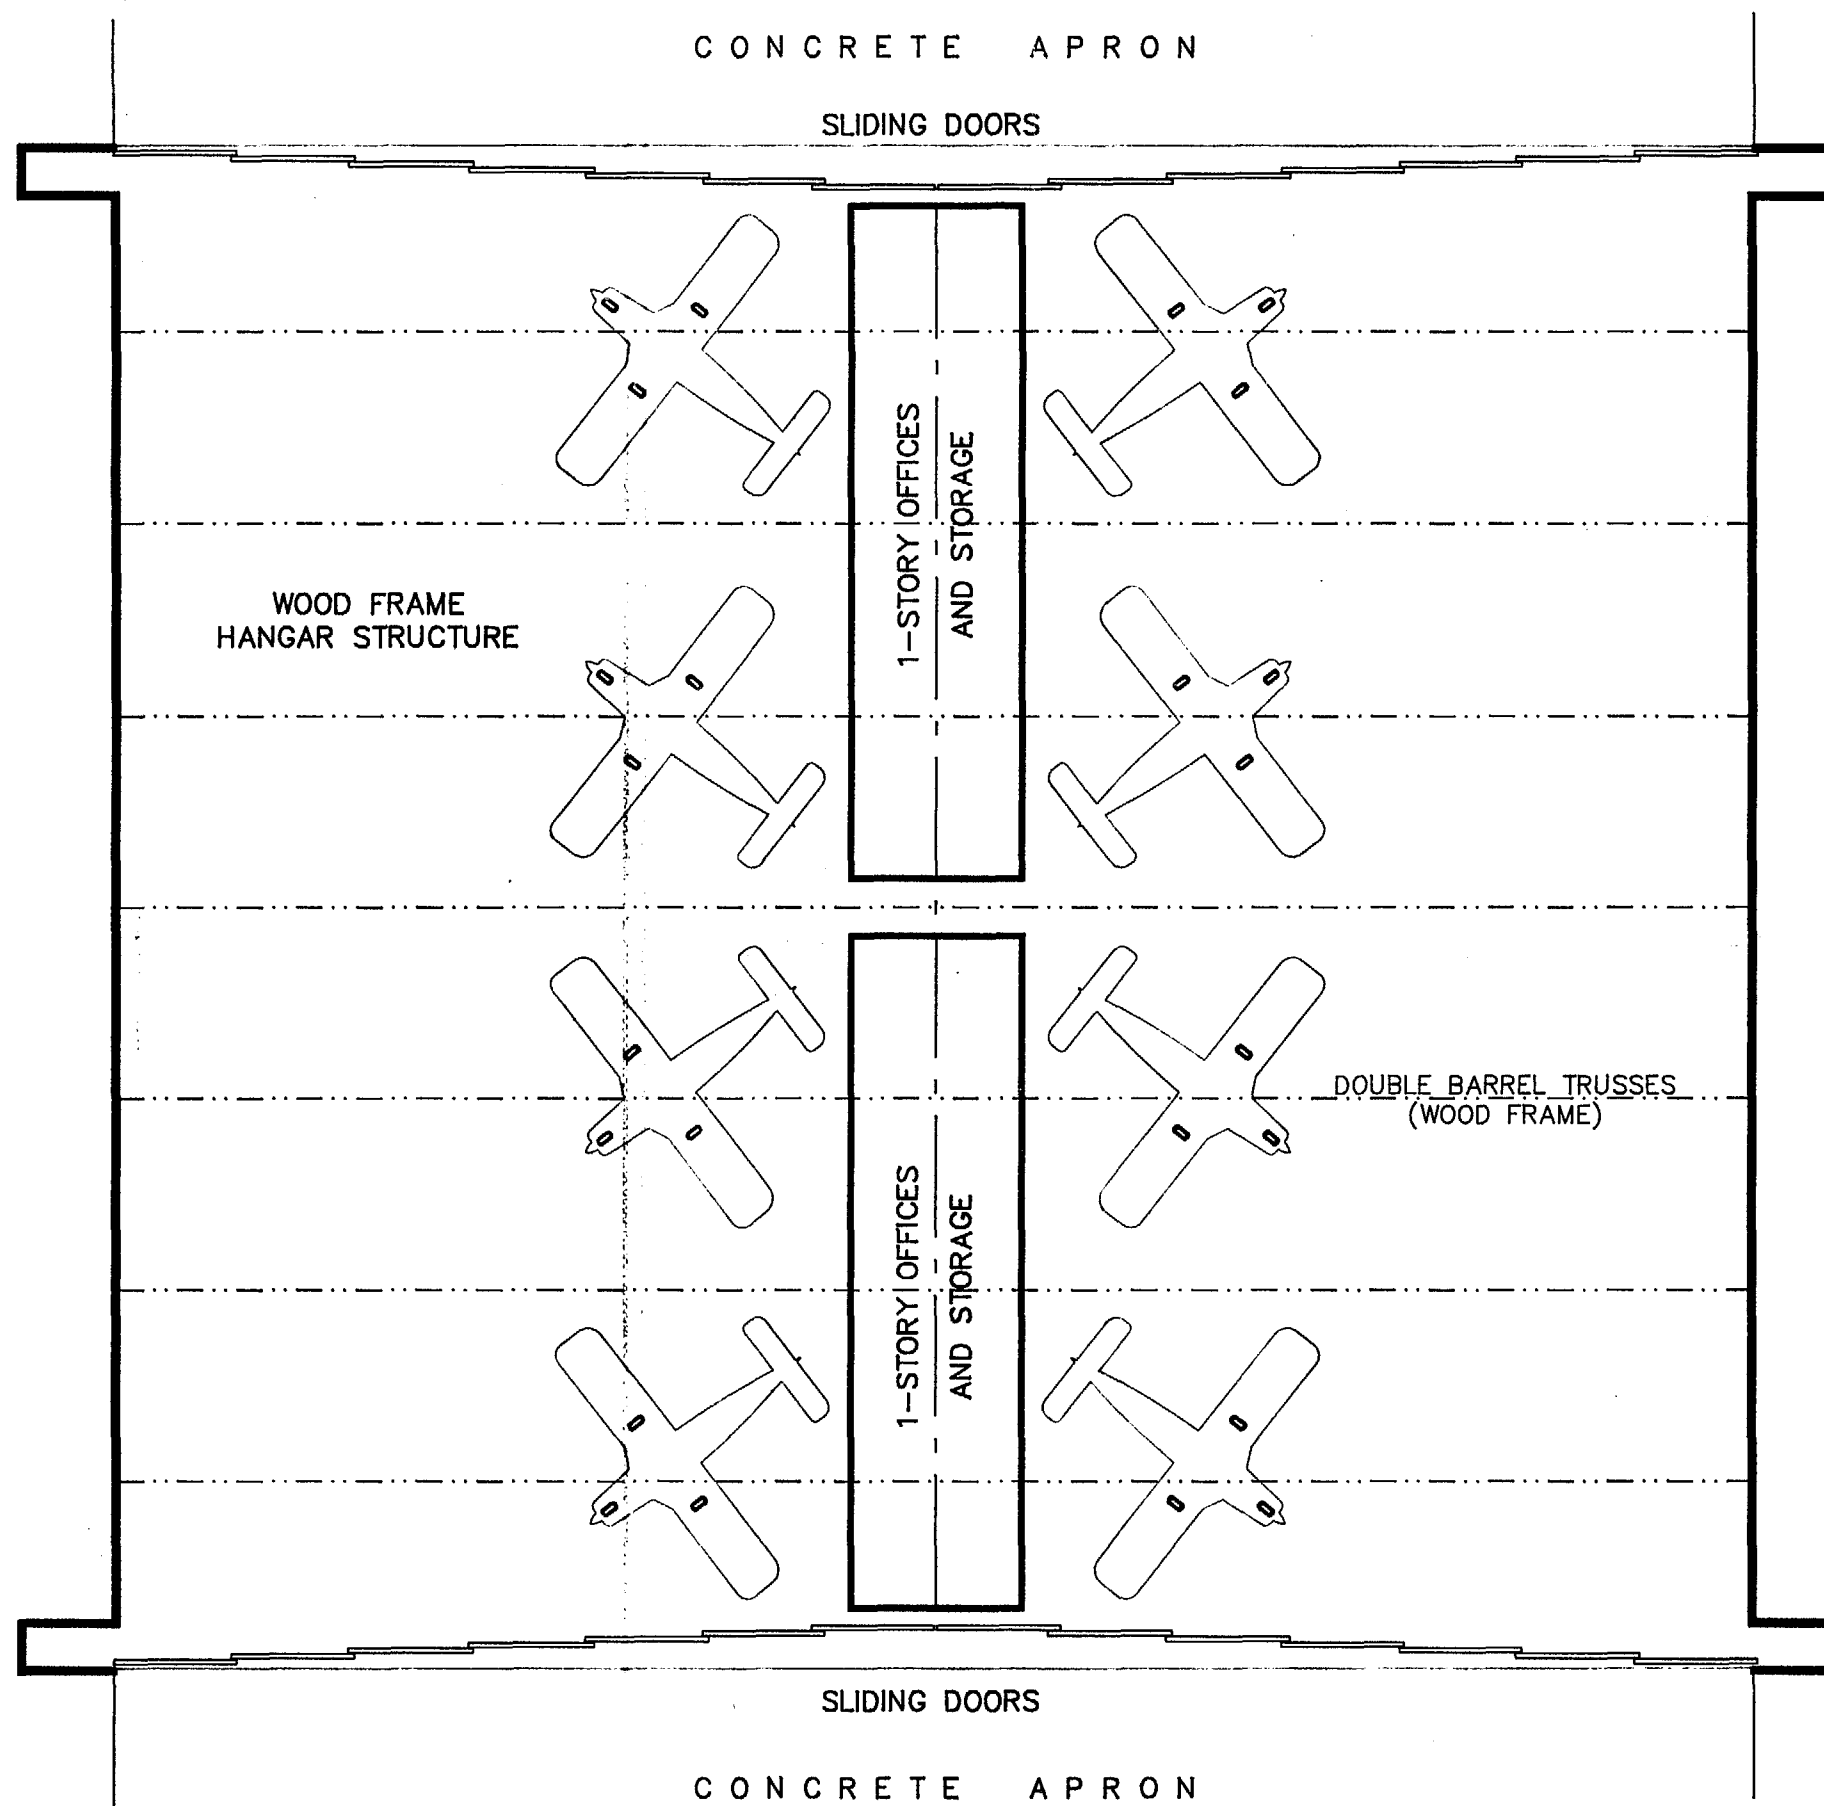
This building was found to be in Good condition. Major detriments are the existence of asbestos in the exterior siding, and bats, birds and mice residing in the building. There is an existing wind cone on the roof of Hangar #4 which is in Good condition.

Thorough investigation and testing of the various structural, electrical, plumbing, mechanical and HVAC systems as well as a hazardous materials investigation is recommended prior to any major remodeling or renovations to this building.

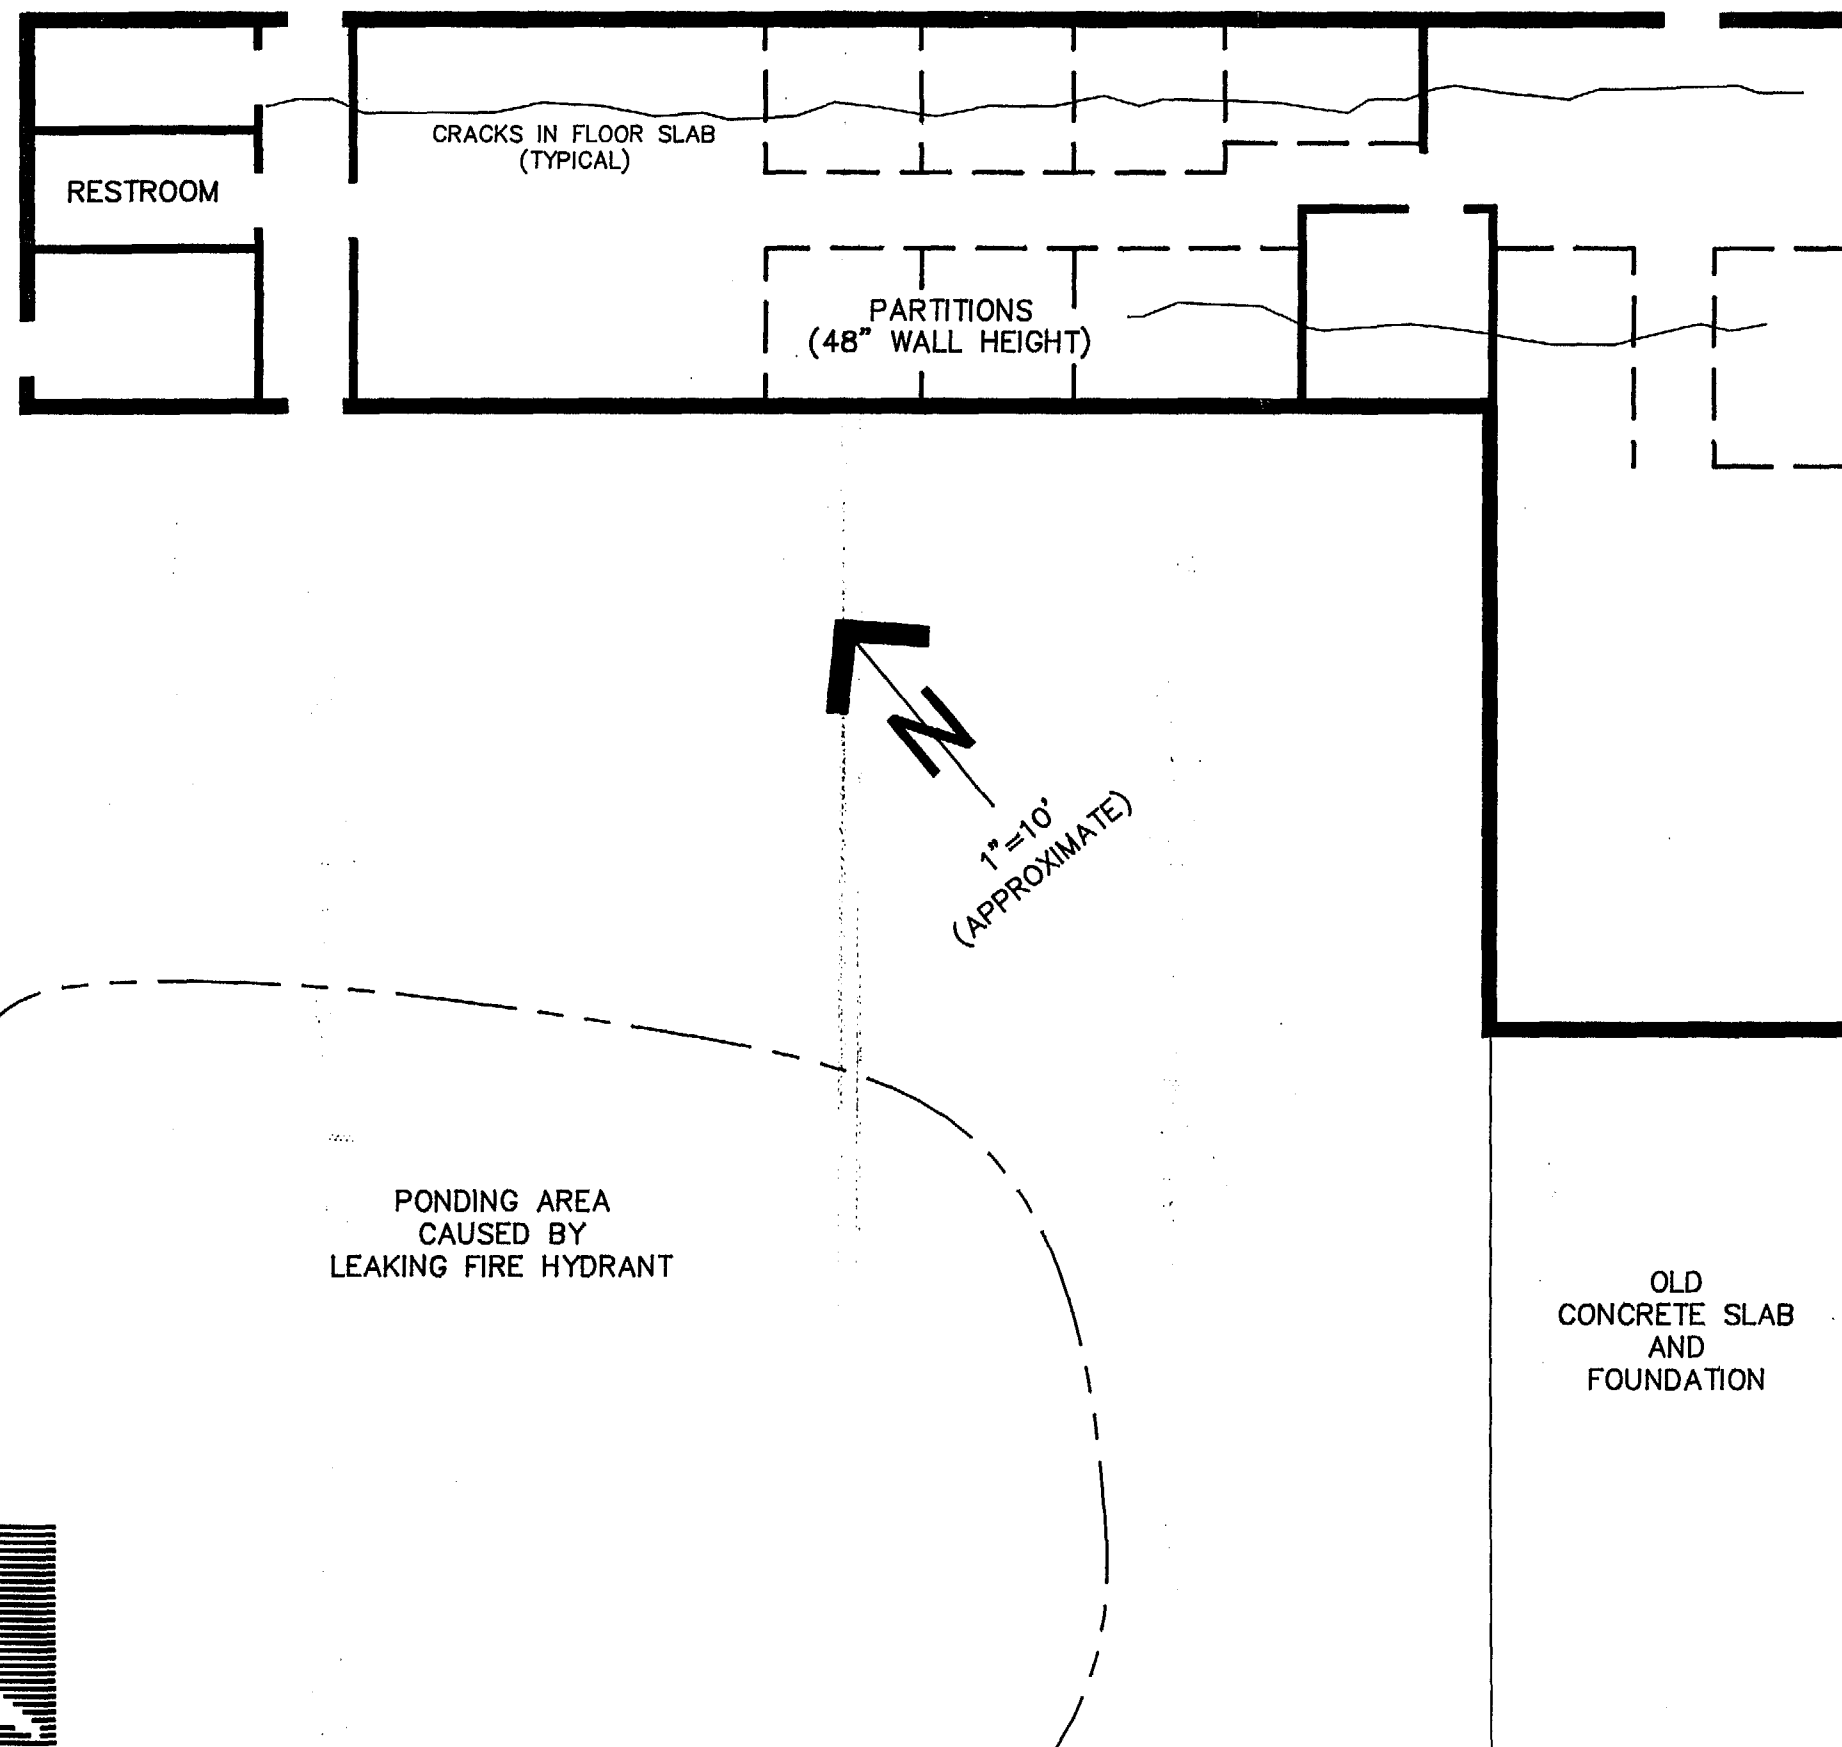
Evidence of water damage caused by a leaking roof was observed. There is a large hole at the low point of a sagging ceiling. The floor slab has 1/2" to 3/4" cracking in evidence, running the length of the building, which has been repaired by filling in the past.

Building #3 is in generally Poor condition. The major detriments to use at this time are the condition of the roof and floor slab. Roof leakage will cause future damage to the remainder of the structure if not repaired.
